Beckfoot Oakbank School - Accessibility Action Plan.

Updated: 10/01/2025

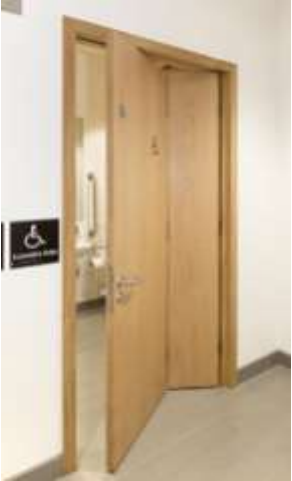
<p>13.3</p>	<p>Most facilities featured doors that suitably opened outwards.</p> <p>The first-floor facility, 637, opened into the doorway of F33, which could be a collision hazard.</p> <p>Facility 638 partially opens into the doorway of F5, which could be a collision hazard.</p> <p>208 partially opens into G16, which could be a collision hazard.</p>	<p>It is recommended to provide bi-folding, or sliding doors for these facilities to reduce the risk of a collision.</p>

<p>M</p>	<p>All toilets are designed and are in specification with accessibility regulations. The doors can only open outwards as the door would not close if opened inwards if a wheelchair was used.</p>
<p>13.10</p>	<p>Items were identified in each of the facilities transfer areas.</p> <p>Items within these areas can prevent a wheelchair user from adopting the appropriate techniques in order to access the facility.</p>	<p>It is vitally important and is strongly recommended that a management procedure be implemented to ensure that accessible WC facilities are always kept clear.</p> <p>☐ This will enable wheelchair users to adopt the many transfer techniques available to them in which an accessible WC is designed to provide. Without a free transfer area, a wheelchair user is highly unlikely to be able to use a facility.</p>	<p>N</p>	<p>These items were medical bins and are needed. The Bins do not obstruct access.</p>

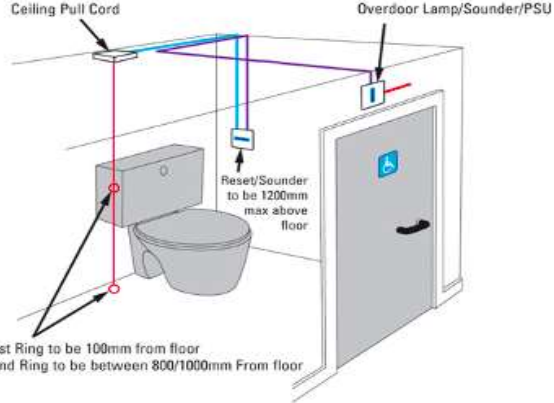
<p>13.11</p>	<p>Many of the facilities featured suitably positioned cord alarms.</p> <p>Tied cord alarms were identified by S44, 830 and 638.</p> <p>The cord alarm in the sports building facility was positioned on the shelf.</p> <p>The cord alarm in the CTMC building was high from ground floor level and a reset button was not identified.</p>	<p>Implement a management procedure to ensure that cord alarms are always kept loose and not tied up.</p> <p>☒</p> <p>According to BS8300 - An emergency assistance pull cord should be sited so that it can be operated from the WC and from an adjacent floor area. The emergency assistance pull cord, coloured red, should be provided with two red bangles of 50 mm diameter, one set at a height between 800 mm and 1000 mm and the other set at 100 mm above floor level.</p>

<p>N</p>	<p>Pull cords will be checked and repairs/adjustments carried out.</p>
<p>14.7</p>	<p>Height adjustable desks were identified in various areas of the school, including IT rooms, Science rooms, Cookery rooms and general classrooms.</p> <p>The height adjustable table provided to G29 had limited space to approach.</p> <p>The height adjustable equipment such as cookers and sinks in the cookery rooms featured obstacles both on the top and along the route towards them. Wheelchair users may find accessing this equipment difficult.</p>	<p>Ensure that the height adjustable equipment is suitable for approach, on demand, by wheelchair users.</p> <p>Ensure that the height adjustable tables are suitably positioned to allow clear access. Spacing between tables should be 1550mm - 2050mm with a minimum of 1050mm width clear of any seating.</p>	<p>N</p>	<p>Ajustable desks are currently not used at the moment as we don't have any students in wheelchairs. Items can be quickly moved and cleared if we do.</p>

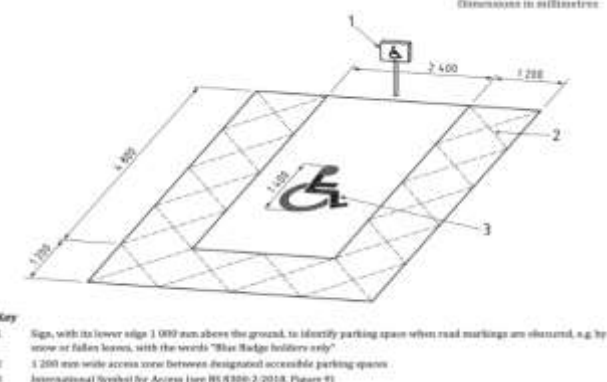
2.2	<p>Posts were identified to the front of the bays; however, these did not feature appropriate accessible bay signage. The signage provided at the entrance to the car park could be improved.</p>

<p>Key</p> <p>1. Sign, with its lower edge 1 000 mm above the ground, to identify parking space when road markings are obscured, e.g. by snow or fallen leaves, with the words "Blue Badge holders only"</p> <p>2. 1 200 mm wide access zone between designated accessible parking spaces</p> <p>3. International Symbol for Access (see BS 6838-2:2014, Figure 4)</p>	<p>Install a sign to the front of any accessible parking space. According to BS8300 - Sign should be present with its lower edge 1000 mm above the ground, to identify parking space when road markings are obscured, e.g. by snow or fallen leaves, with the words "Blue Badge holders only".</p> <p>Refer to BS8300, A sign or, if appropriate, signs should be provided at the entrance to each car park and at each change in direction to direct disabled motorists to designated parking spaces.</p> <p>As the signage provided is updated, consideration should be taken to removing the word "disabled" and replacing it with "accessible" or "Blue Badge Holders".</p>	M	Signs to be ordered

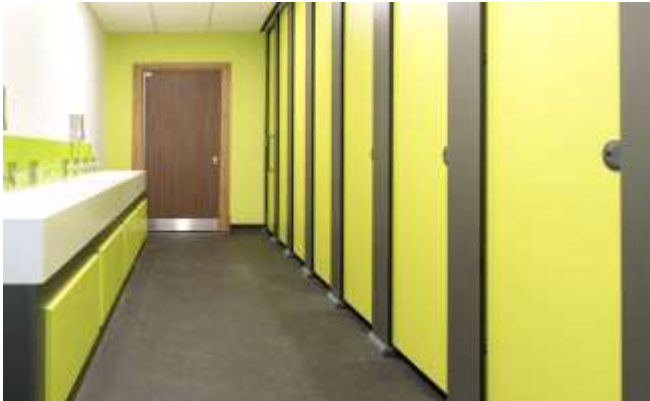
12.4	<p>The lock was slightly broken on the female, staff facility on the second floor.</p> <p>Student WC facilities did not have contrasting cubicle doors as they were the same colour as the frames. This could be confusing for people who are partially sighted.</p>	<p>Site management to schedule maintenance and repair of the lock for the staff, female facility on the first floor.</p> <p>Cubicle doors throughout should appropriately colour contrasted to identify doors within frames to aid people with impaired vision. A difference of 30 points LRV (Light Reflectance Value) is recommended as appropriate contrast.</p>

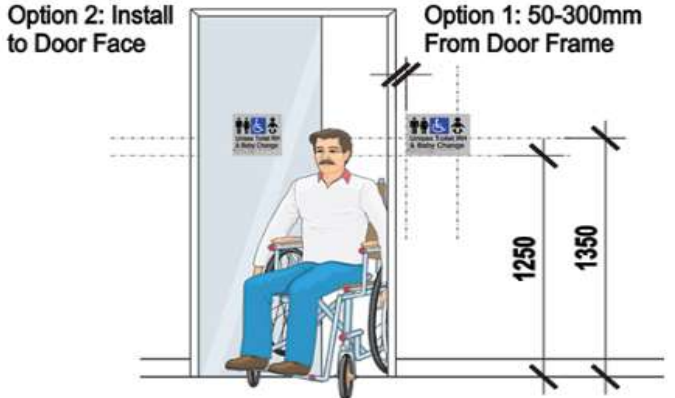
<p>15.3</p>	<p>Most facilities featured suitable signage across the school.</p> <p>The shower room for staff, in the sports centre, was not suitably sign posted to assist with identifying its location.</p> <p>There is accessible WC signage positioned marginally high from ground floor level, at approximately 1470mm, which may not be a suitable height for all eye levels.</p>

<p>The appropriate signage should be provided for the staff facilities in the sports centre. As well as signage on the doors, there should also be signs indicating where the facilities are located.</p> <p>BS8300 states - Information and direction signs should be provided at each point where they are required, e.g. at junctions of circulation routes, at key locations such as doorways and reception points, at facilities such as telephones and toilets, and in rooms, spaces and counters. The colour, design and typeface of signs should be consistent throughout a building.</p> <p>All accessible WC door signage should ideally be accessible to all disabled people with Braille and embossed lettering preferred. This should be suitable positioned for all eye levels.</p>	<p>M</p>

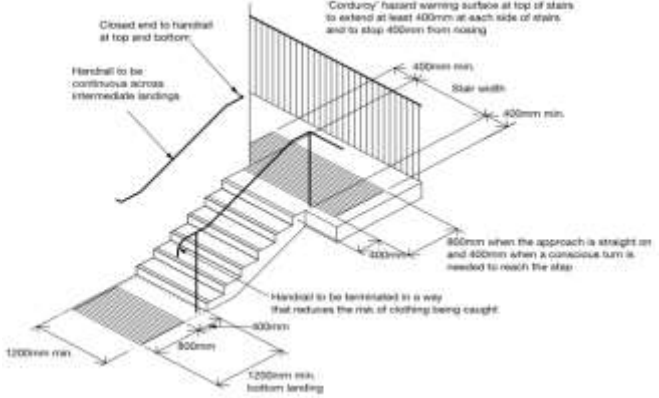
<p>4.1</p>	<p>Tactile warnings were provided to the steps that lead from the car park, towards the main entrance.</p> <p>The remaining external steps identified did not feature tactile paving to the top or bottom, which could assist people who are blind or partially sighted, by providing prior warning of the steps.</p>

<p>Implement a rolling programme to install tactile paving to the top of the external steps throughout the site.</p> <p>BS8300 - To give advance warning of a step, tactile paving with a corduroy hazard warning surface should be provided at the top and bottom of each flight, excluding intermediate landings with continuous handrails. Where the approach to the stair is wider than the flight, the tactile surface should extend beyond the line of each edge of the flight.</p>	<p>M</p>	
<p>4.3</p>	<p>Are all external steps adequately lit during darker hours?</p>	<p>Site management should undertake a review of the step lighting levels during darker hours to ensure that the step treads are evenly lit.</p> <p>Lighting on external steps and ramps should achieve a minimum level of 100 lux where they are external and adjacent to entrances/exits of buildings.</p>	<p>N</p>

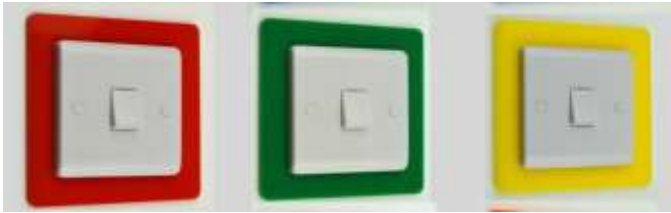
<p>16.2</p>	<p>Many of the light switches were well contrasted against their surroundings.</p> <p>The light white switch plates against light surroundings may not provide sufficient contrast to assist people who are partially sighted.</p>

<p>At the next refurbishment for the sites, it would be beneficial to change the existing light switch plates with alternatives that have a grey/silver plate. Alternatively, a contrasted border could be provided. This will ensure that they are easily located by people with impaired vision.</p> <p>All switches that require precise hand movement, such as light switches, thermostats etc, should be located between 750mm – 1200mm from floor level.</p>	<p>M</p>	
<p>16.4</p>	<p>Wall lighting was identified in stairwell 1, as well as the sports building stairwells.</p> <p>Wall lighting can create glare for people who are partially sighted.</p>	<p>Each flight and landing of a stepped access route should be well illuminated, providing a clear distinction between each step and riser. The illuminance at tread level should be at least 100 lux. Lighting that causes glare (such as poorly located wall lights, spotlights, floodlights or low-level light sources) should be avoided.</p>	<p>M</p>
